## WELLINGTON SPCA

### REPORT

**Facility name:** Helderstroom Correctional Services

**Date:** 2025-03-19

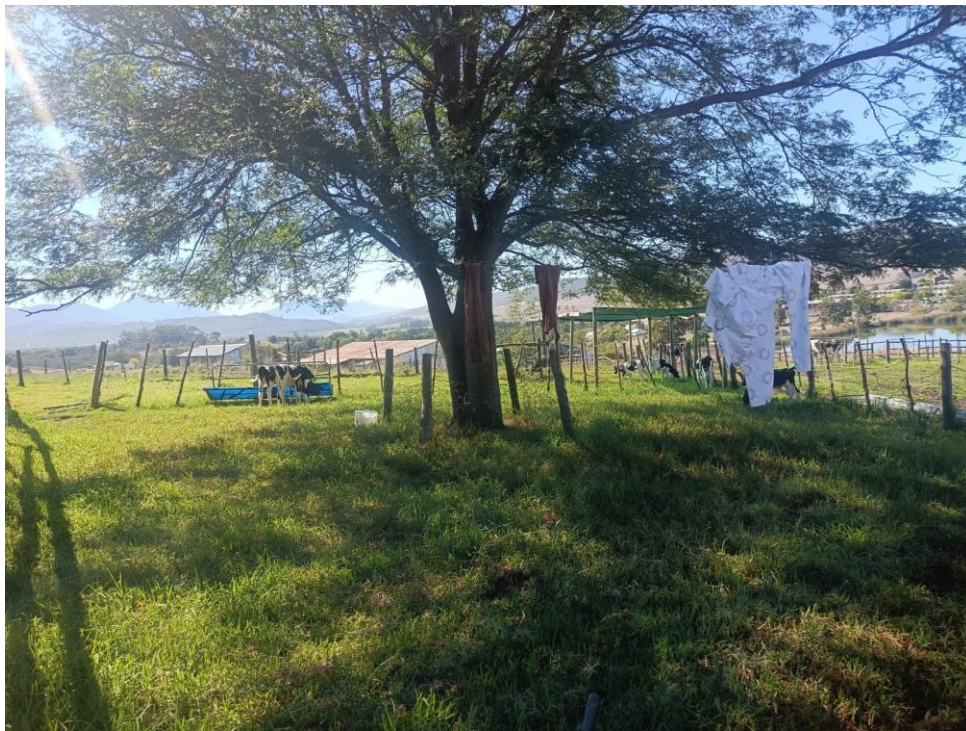
At 10h35 we started with the inspection at the dairy accompanied by Mr. Magadla. The calves are kept in an outside camp during the day. This camp has grass and a tree for shelter. They get fed with dairy feed for calves. The calves did seem underweight. The fencing of this outside camp was also in disrepair with protruding metal and holes. The walkway between the camps was also covered with excess faeces.

*Figure 1: Outside enclosure where calves are kept during the day.*

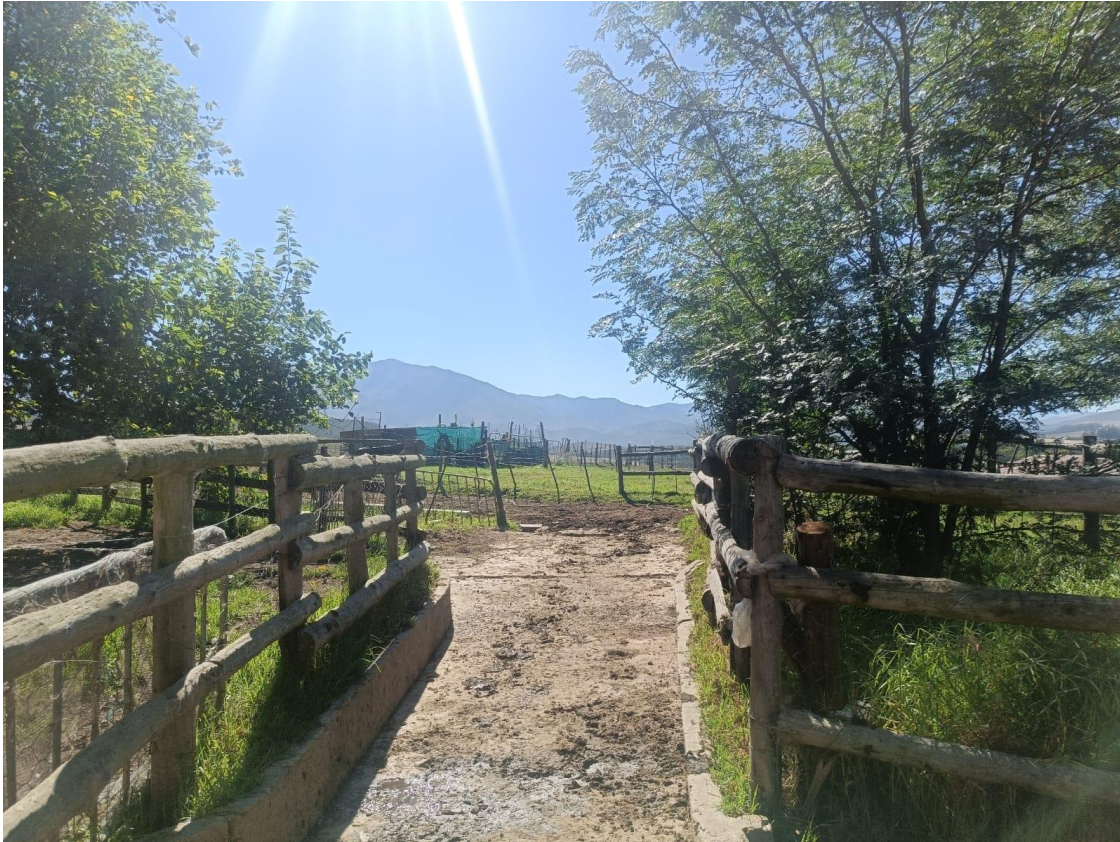
*Figure 2: Walkway with excess faeces causing parasitic conditions.*

- 7) Cleaning of dairy cattle enclosures from excess faeces to prevent spread of disease.
- 8) Lack of feed for dairy cattle and broken irrigation systems for crop production.

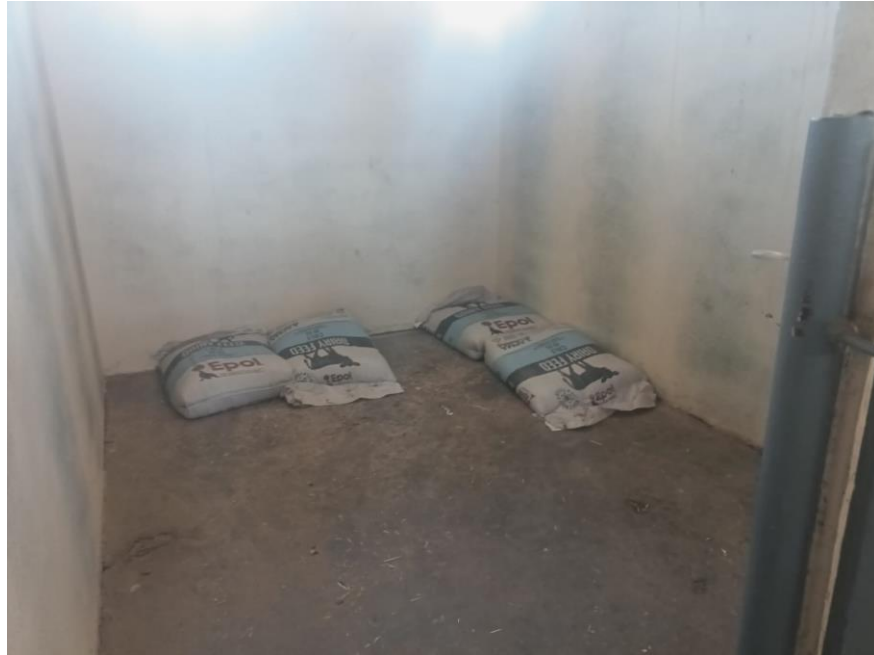
When asked about the food that the dairy cattle and calves are being fed, Mr. Magadla claimed that they only have about 30 bales of lucerne and 180kg of dairy feed for calves left for all dairy cattle. The adult cattle that were in the outside fields had grass as ad hoc feed. He claimed that a small delivery of feed will be coming for the cattle on Friday the 21<sup>st</sup> of March 2025. He then also claimed that their irrigation system is broken and that all the dairy cattle's water must be filled manually by water tanks, buckets or hose pipes. This is also a major issue as they cannot grow crops at the moment to produce feed for the livestock on site. He claimed that the process of fixing the irrigation is in motion and for now they must buy food for the animals weekly or ask Brandvlei- or Voorberg Correctional Services to assist them with feed. We also went to the building where the calves are kept at night. This area was sufficient except for the fencing being broken and dilapidated. I informed him that they might as well replace this as the calves can easily injure themselves.

*Figure 3: Concentrates available for all cattle on site (Dairy feed Calf).*

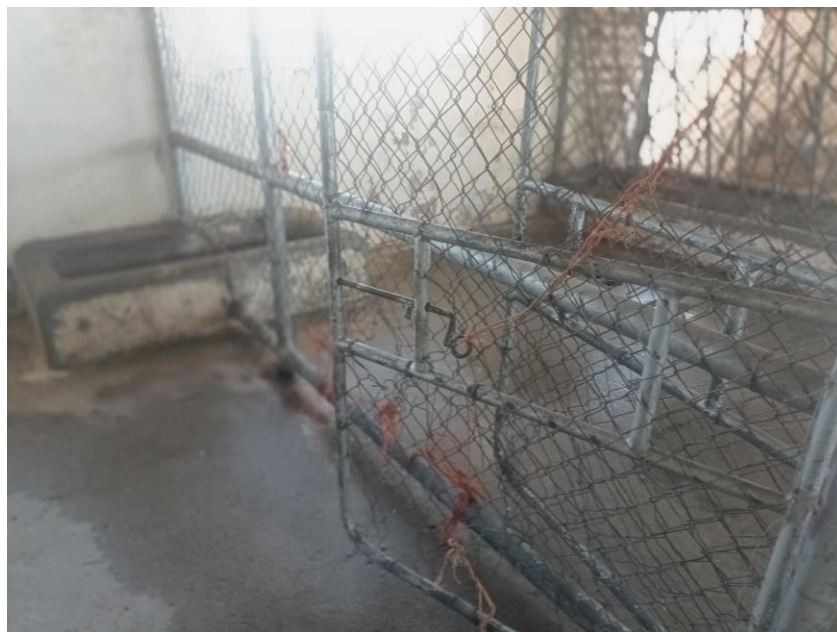
*Figure 4: Broken fencing in calf indoor night shelter.*

- 6) Cleaning of dairy cattle enclosures from hazardous material such as poles, bricks, broken gates, dilapidated fencing etc. that can cause injury to the animals present.

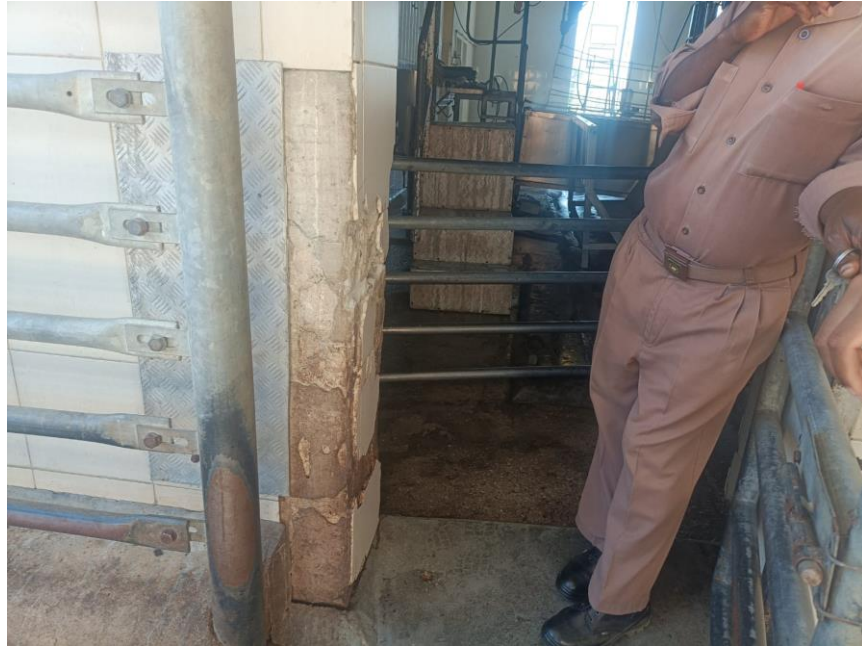
*Figure 6: Visual of the entrance of the pig slaughter area with no visual obstruction to the slaughter area.*

We then went to where the pigs get slaughtered around the corner. They have two Jarvis electrical stunning tongs on site. They slaughter about 60 pigs a day. The pigs get stunned by the entrance and then when inside they are cut to bleed out for 8 minutes. I noticed that the pigs waiting to be slaughtered and the ones getting stunned have a full view of the butcher area and would be able to see carcasses of other pigs clearly. The run is also very wide. I advised Mr. Mrubata on solutions to obstruct the view for the pigs waiting to be slaughtered by suggesting plastic curtains and closing the rails with metal sheets or thick shade cloth. I also educated him on pig boards to move pigs through the run.

- 9) Broken freezers to keep edible meat delaying abattoir functions and emergency slaughter protocols.
- 10) Pigs observing other pigs being slaughtered and butchered.

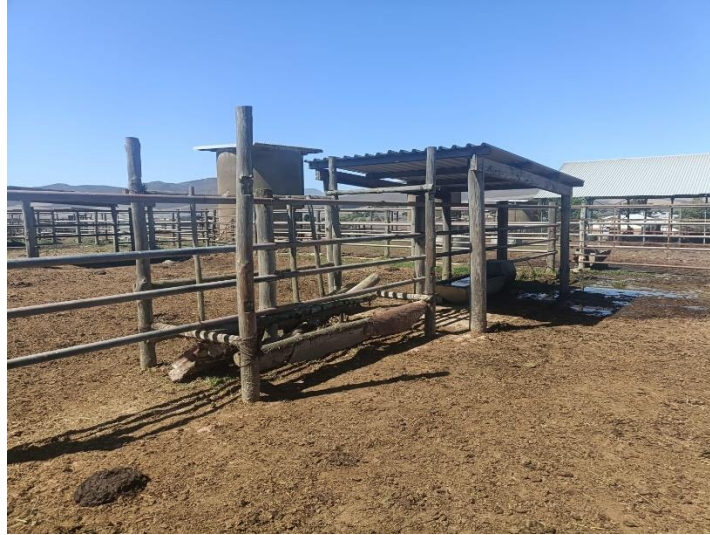
We then went to their overnight sheltered camp. This area had excess faeces that needed to be cleaned. There were also old, rusted feeding troughs that are not being used but can pose a risk for serious injury when cattle are kept in here. I then informed Mr. Thebe that they need to properly clean this enclosure from excess faeces and remove the old, rusted food troughs.

*Figure 9: Old, unused, rusted trough seen in outside night cattle enclosure.*

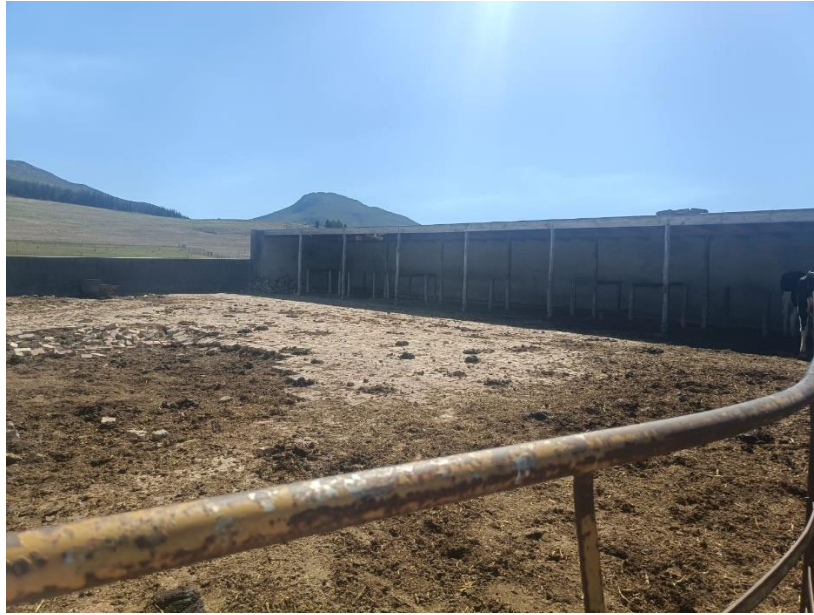
There were also about six enclosures outside for cattle and calves to be kept. These camps were very run down and dirty with excess faeces and poor drainage. Cattle and calves were present inside these enclosures upon our inspection. We noted that there was a pile of bricks in each of these camps with paving built but not finished. Mr. Thebe claimed that they started to fix the flooring of these camps for drainage and then the funding to finish it stopped and it has been left like this for a year now. I then suggested to neatly finish the paving off with a straight line of bricks and cement and also use cement for a proper drainage line. I also said they need to remove the pile of bricks, rubble and loose bricks as this can cause serious injury to cattle kept here. I also noted some of the gates were old, rusted and had protruding sharp edges. They use one of these camps for maintenance that has a brand-new gate. I therefore suggest that they swap the broken gate with the new gate at the maintenance camp or replace all of the old gates. Mr. Thebe agreed that this part of the farm needs lots of fixing.

*Figure 10: One of the outside camps with hazardous material and excess faeces seen with cattle inside.*

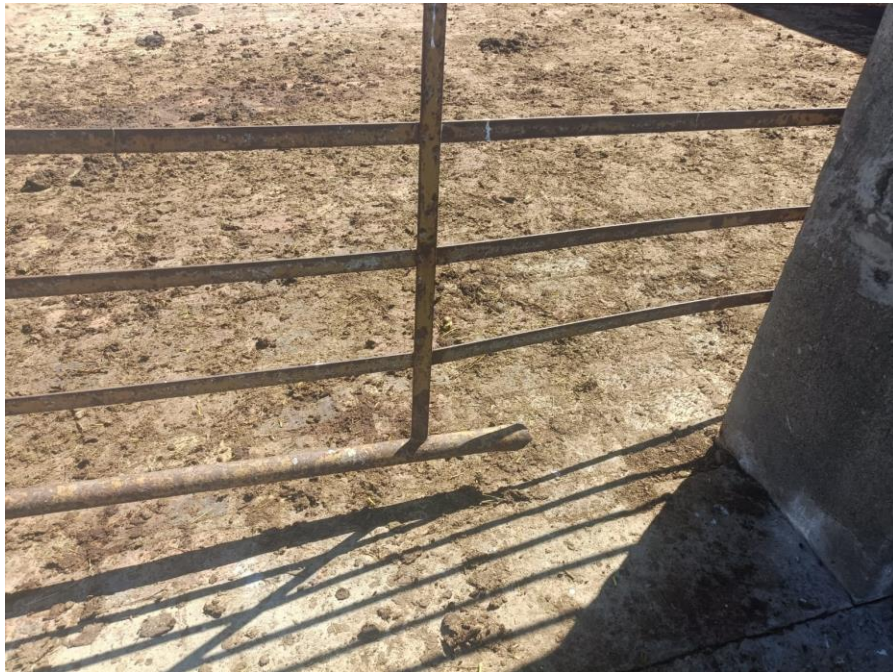
*Figure 11: Broken, rusted gate with a sharp edge at one of the outside camps holding calves.*

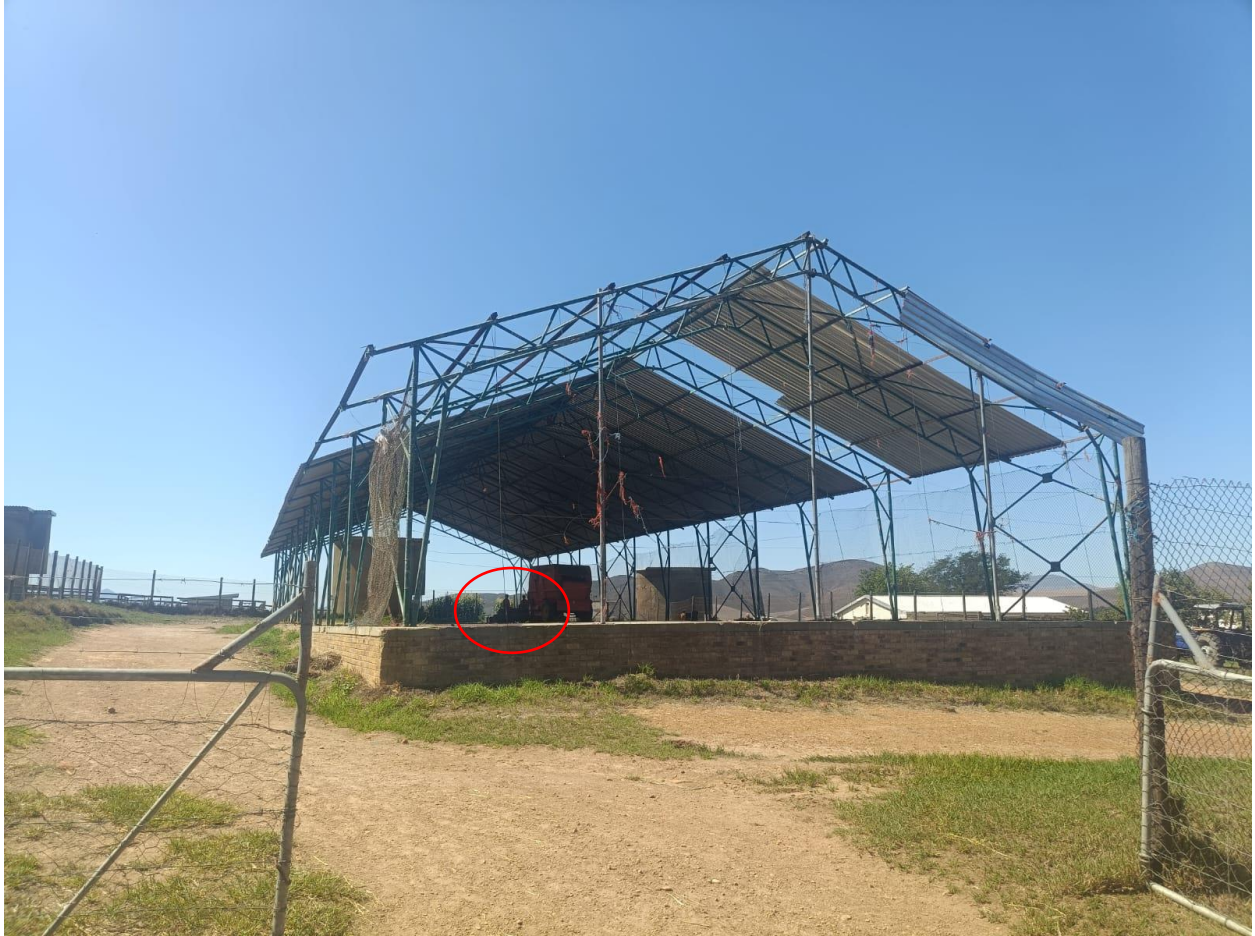
He also showed us a large outside sheltered structure where they supposedly keep the bales. This is where I only observed about 30 bales left to feed all the cattle. They usually feed Lucerne bales, 19% concentrates and Oathay pellets to the cattle from a company called MRN.

*Figure 12: Outside holding facility where bales are kept. Red circle shows two people and behind them are the thirty bales left for ad hoc feed.*

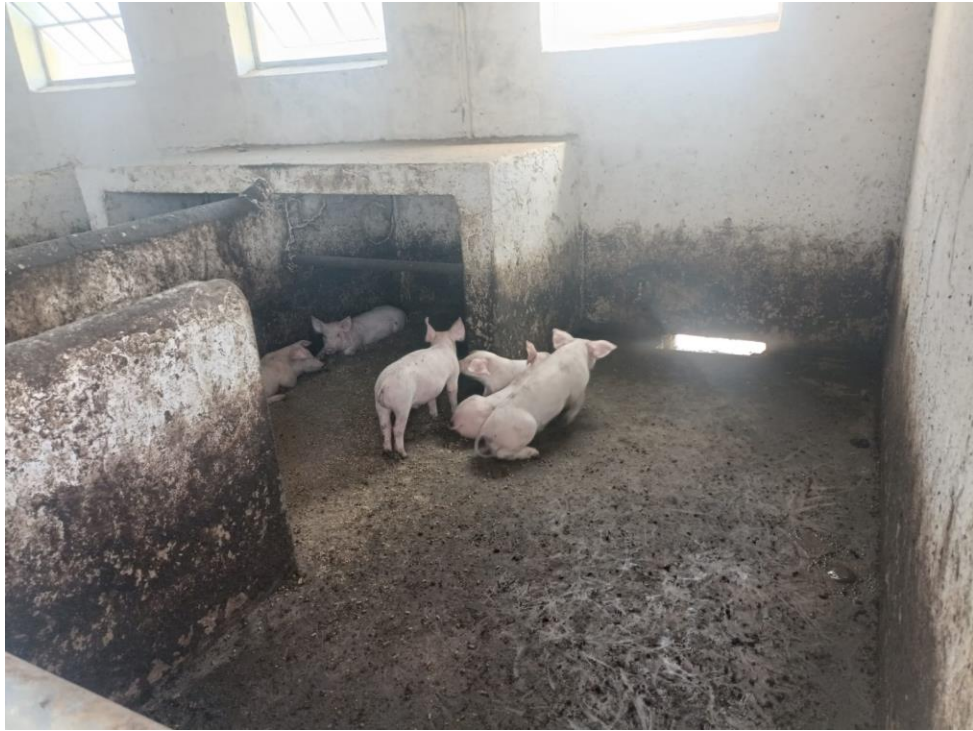
*Figure 15: Piglet house still in need of cleaning.*

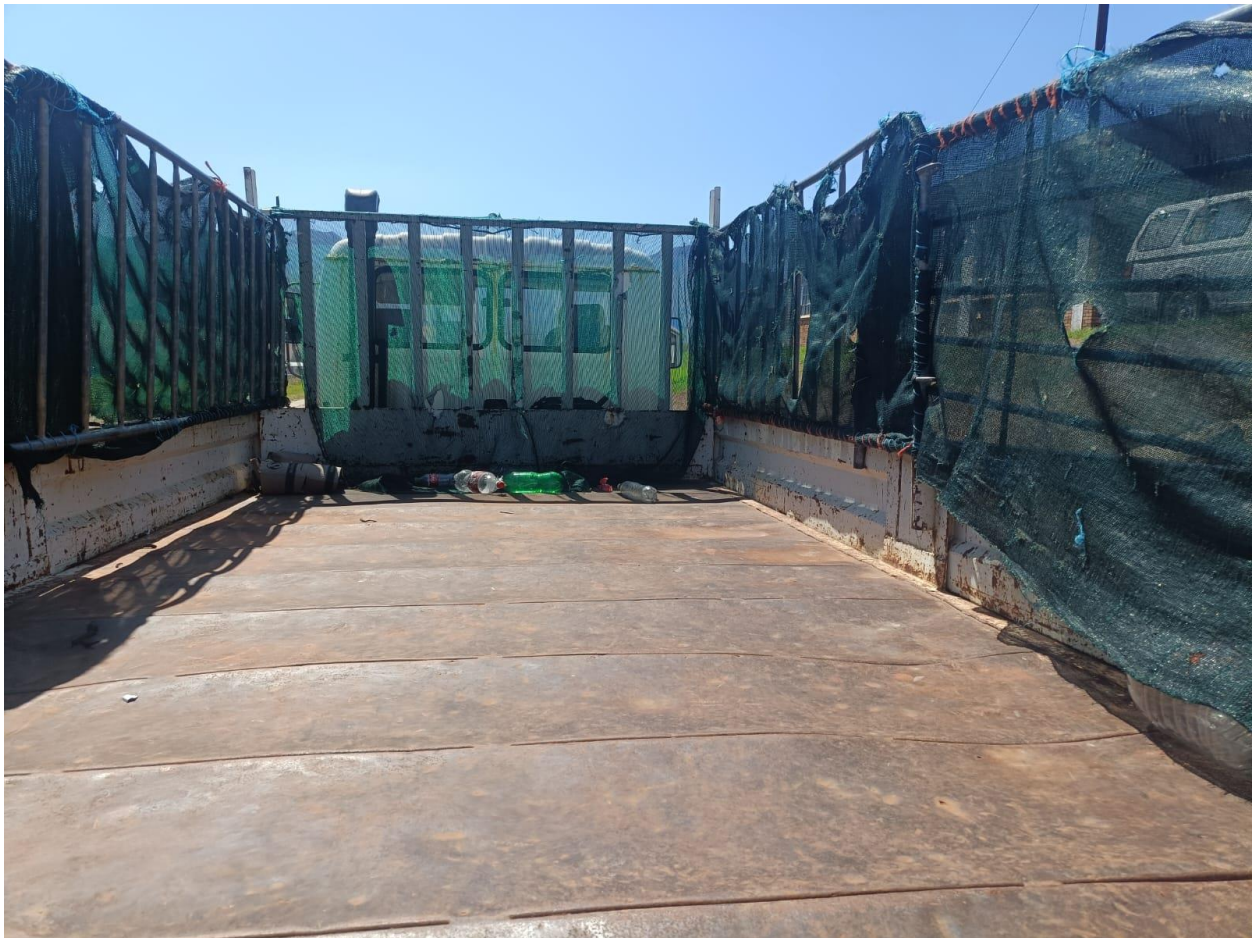
There were several issues found with the truck. One of the side rails was hanging loose and not fastened correctly. This can cause escape and injury to animals being transported. Mr. Thebe claimed that they throw sand in the truck to provide non-slip flooring when transporting animals. I said this is okay if enough sand is thrown in, but I strongly suggest that they get a fitted metal grid or adequate rubber as non-slip flooring. I showed him Brandvlei's truck, and he appreciated the ideas I gave him. There was also rubbish inside the truck. I informed him that no rubbish should be kept in the back of the truck. The truck is also not equipped to transport pigs as they do not provide protection from the elements.

*Figure 17: Livestock truck showing no protection against the elements, rubbish and a broken rail on the right hand side.*

- 4) The piggery obtaining their own emergency slaughter equipment to keep on site.
- 5) The presence of rubble, a broken rail, absence of shelter and absence non-slip flooring inside the livestock transport.
