## WELLINGTON SPCA

### REPORT

**Facility name:** Helderstroom Correctional Services

**Date:** 2025-03-19

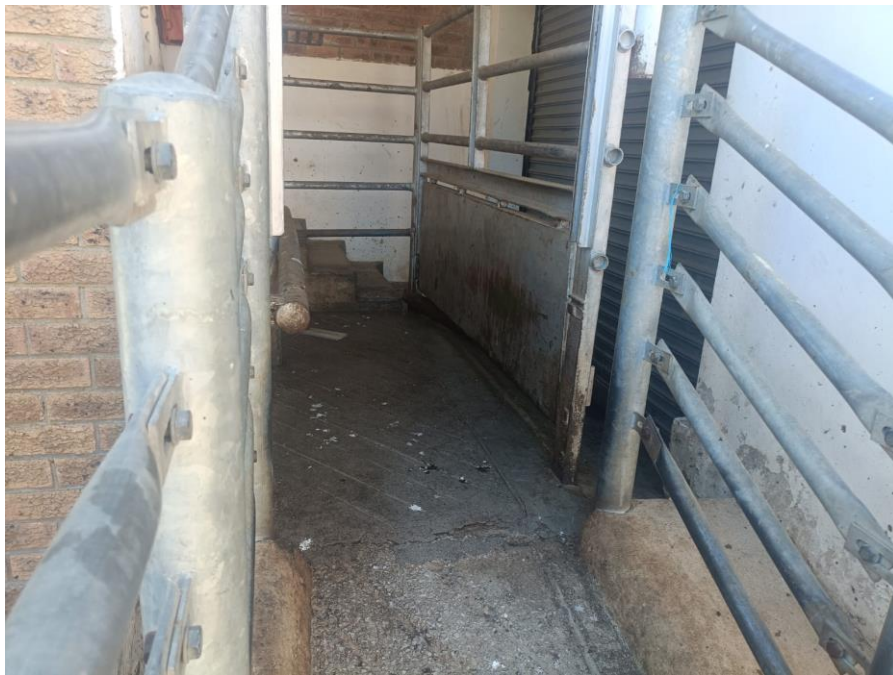
We observed the cattle run and found this to be acceptable as the cattle kept in waiting would not be able to observe the slaughter of the cattle. The cattle get stunned and then roll inside the building with an opened metal side to get cut inside. All the equipment for the abattoir for slaughter is sufficient. They use a .22 captive bolt pistol to stun the cattle and a butcher knife to cut the throat. They have two captive bolt pistols on site which they keep safely locked away in their offices.

*Figure 5: Cattle stun area.*

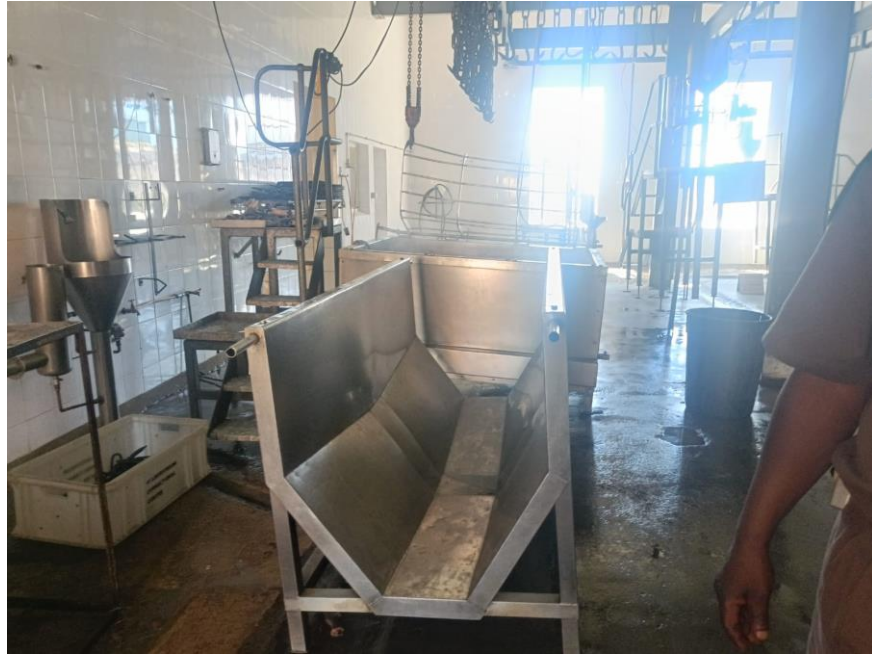
We then went to where the pigs get slaughtered around the corner. They have two Jarvis electrical stunning tongs on site. They slaughter about 60 pigs a day. The pigs get stunned by the entrance and then when inside they are cut to bleed out for 8 minutes. I noticed that the pigs waiting to be slaughtered and the ones getting stunned have a full view of the butcher area and would be able to see carcasses of other pigs clearly. The run is also very wide. I advised Mr. Mrubata on solutions to obstruct the view for the pigs waiting to be slaughtered by suggesting plastic curtains and closing the rails with metal sheets or thick shade cloth. I also educated him on pig boards to move pigs through the run.

*Figure 7: A visual of the inside of the abattoir.*

He was very interested on advice and said he will make a plan to fix this as soon as possible.

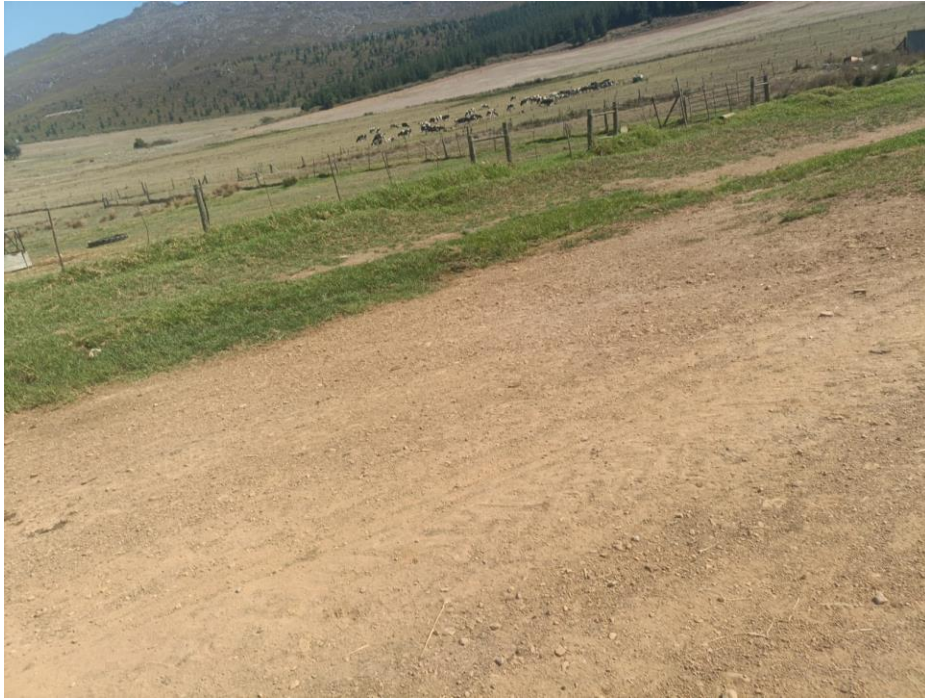
At 11h02 we proceeded to where the adult cattle were kept in the fields and to their overnight camps. Most of the adult cattle were outside in the field. They had a water tank out in the field where the cattle are kept providing drinking water for them whilst the irrigation system is broken.

*Figure 8: Where most of the adult cattle are kept in the field.*

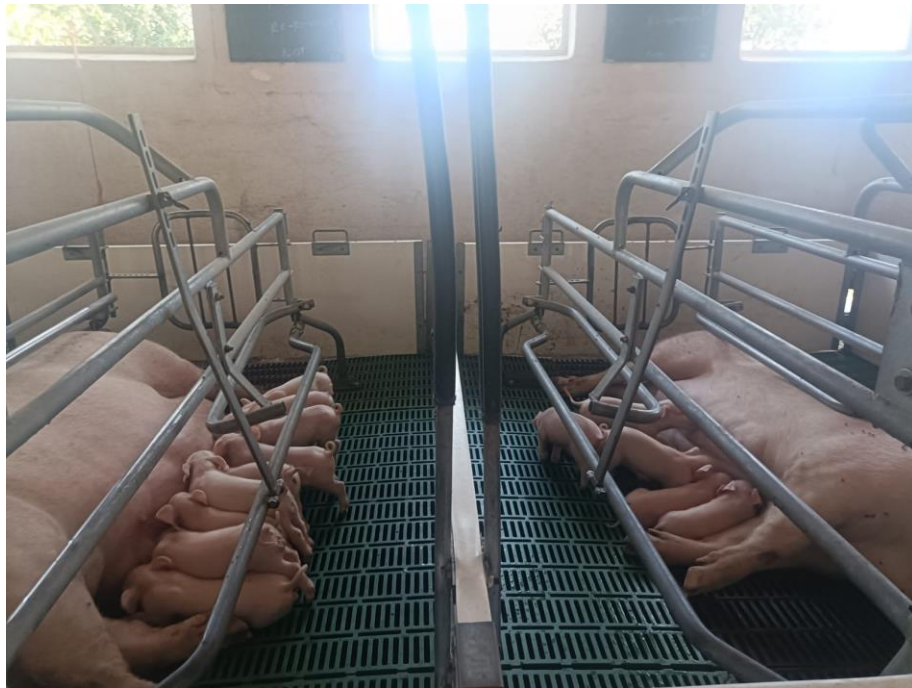
We first went into one of the sow houses. This area was very clean and well maintained. The plumbing works perfectly here as all the nipples worked very easily. We then did a walk through and found one of the piglets busy dying. I then asked Mr. Thebe what they do in situations like this that happen frequently. He then claimed that they would leave the piglet to inside with the mother and other piglets until it dies and then remove it. I then told him that this is unacceptable and that they need to place emergency slaughter protocols in place.

*Figure 13: Example of sow holding areas including heat lamps.*

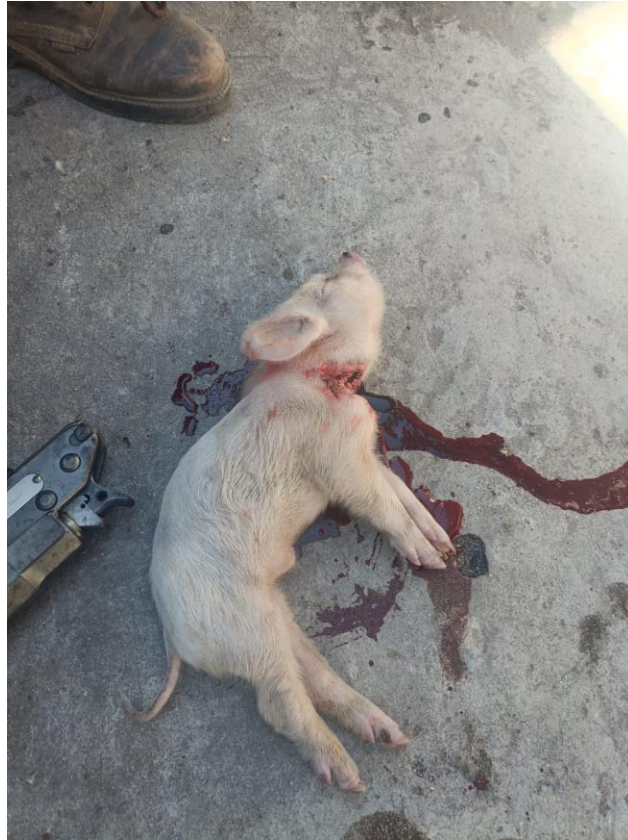
I then instructed Lewis to fetch our captive bolt pistol and butcher knife. We then took the piglet outside to show the staff how to conduct an emergency slaughter. Lewis shot the piglet and I cut its throat. I then told Mr. Thebe that it is of utmost importance that he obtains his own emergency slaughter equipment for this facility on the farm.

*Figure 14: Piglet after performing an emergency slaughter.*

- 4) The piggery obtaining their own emergency slaughter equipment to keep on site.
- 5) The presence of rubble, a broken rail, absence of shelter and absence non-slip flooring inside the livestock transport.

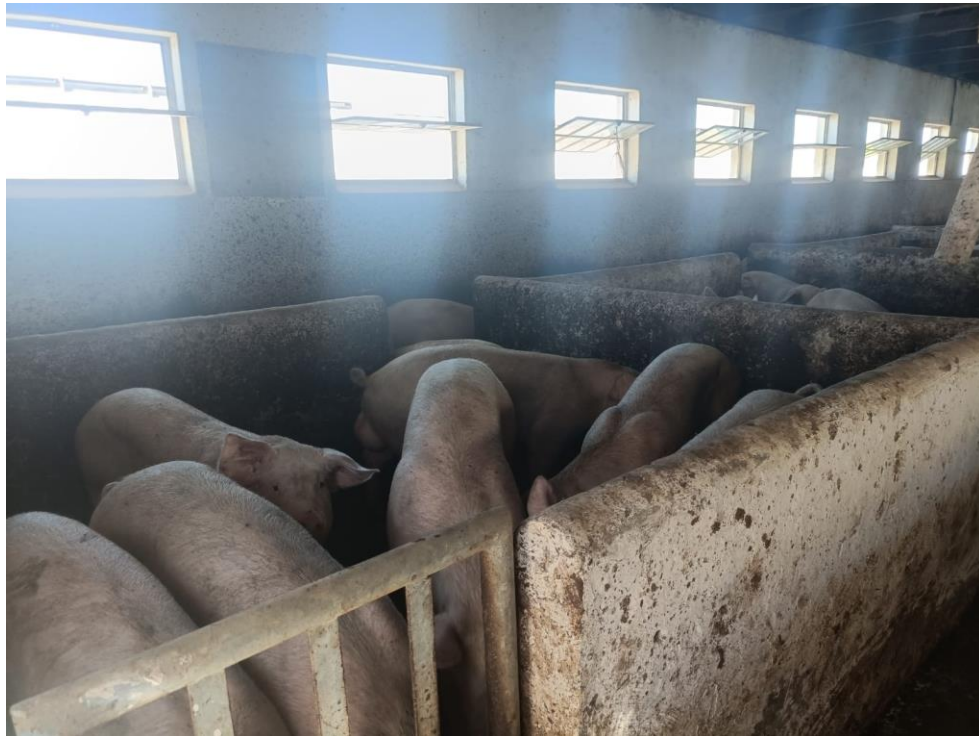
*Figure 16: Adult pig holding facility.*
