## **WARNING # 21263**

Following the Qurbani slaughter activities conducted between 6th and 9th June 2025, several concerns were observed with regard to animal welfare, equipment condition, and facility hygiene. These issues must be addressed immediately and fully rectified before Qurbani 2026 to ensure compliance with ***Animals Protection act 71 of 1962***.

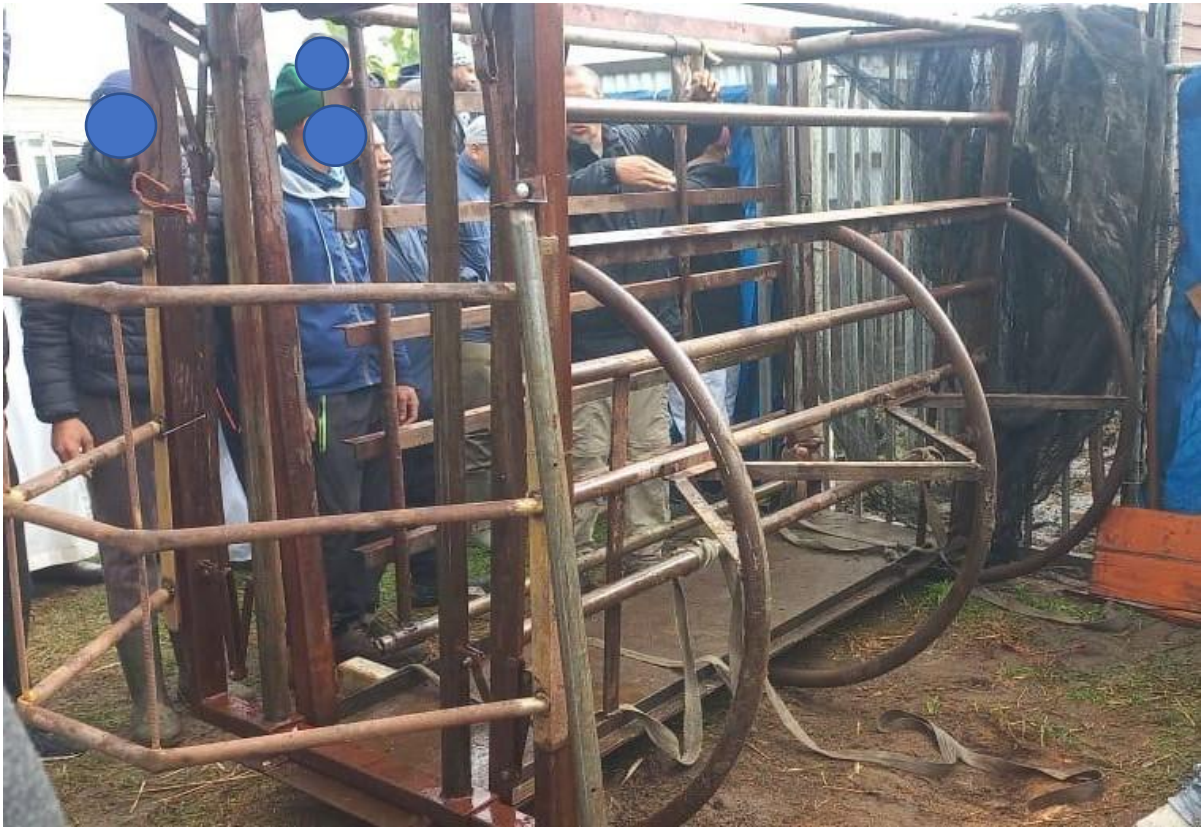
SL1  
Large crush system

- 1. Inadequate and Poorly Maintained Cattle Crush:** The crush used during the slaughter is poorly maintained and no longer suitable for the size and strength of the cattle. Its current condition poses significant safety and welfare risks to the animals and handlers. A suitable, well-maintained crush that can safely restrain large cattle must be provided before the next Qurbani event, See attached picture of crush that is recommended hereto marked "**SL1**"

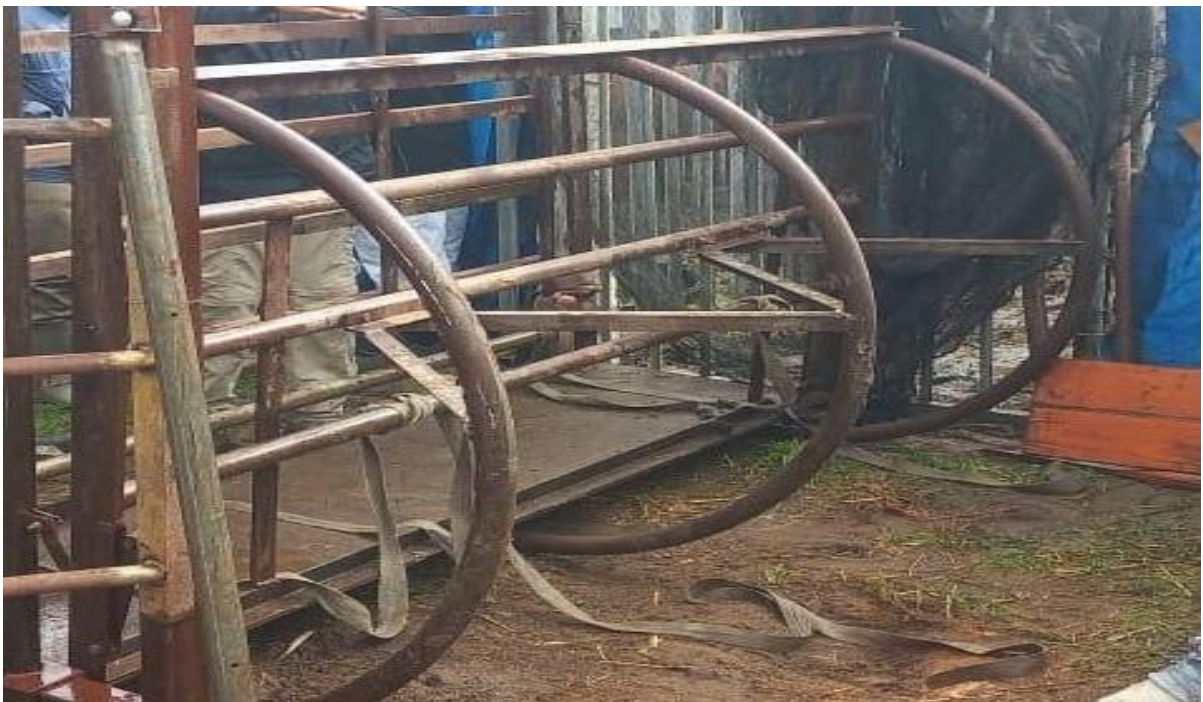
SL2

- 2. Excessive Noise and Stress from Block and Tackle System:** The block and tackle system used to tilt the crush produces excessive noise, which distresses the cattle. This often leads to animals panicking and injuring themselves. It is strongly recommended that a zero-noise alternative be implemented, such as a half-moon bent pipe mechanism to tilt the crush quietly and smoothly. See attached example that is recommended hereto marked "**SL2**"

Half moon steel pipes (acts as a wheel went tilted.

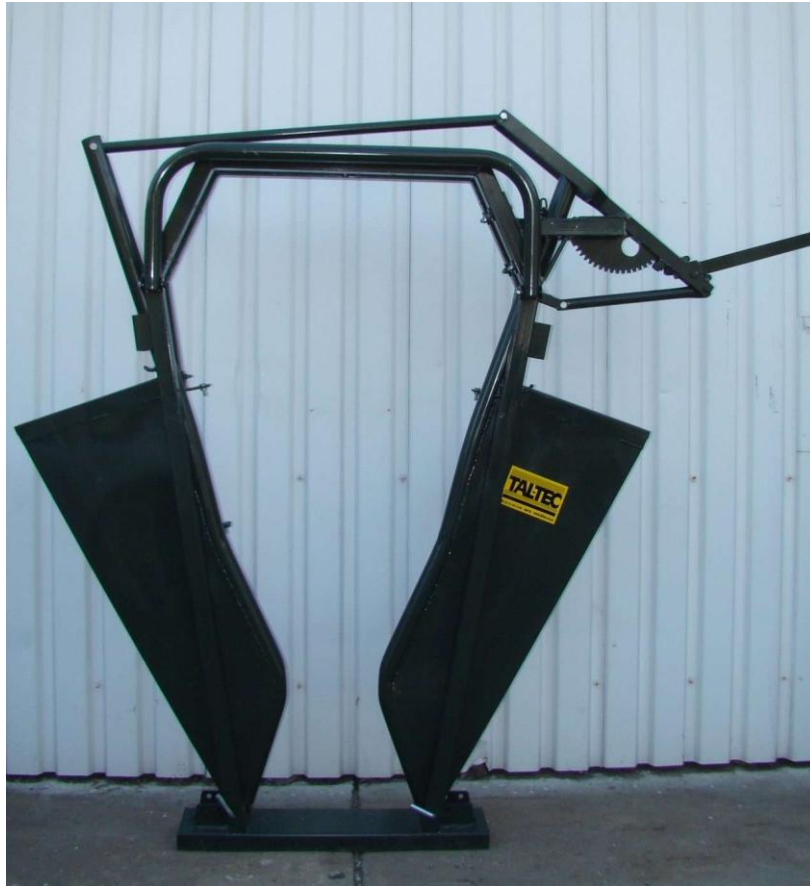
### SL3

- 3. Ineffective and Inhumane Neck Clamp:** The neck clamp currently in use is inadequate and unsafe. It is too loose to properly restrain cattle and is often closed with excessive force, leading to increased stress and panic in the animals. A secure, humane locking neck restraint must be installed to hold the animal's head gently but firmly. See attached example that is recommended hereto marked "**SL3**"

#### Neck clamp that is required and fitted to the crush
